## Thermal Imagers and Marine Inspections

**By Charles J. Hazouri,**

# Offshore Marine Inspections

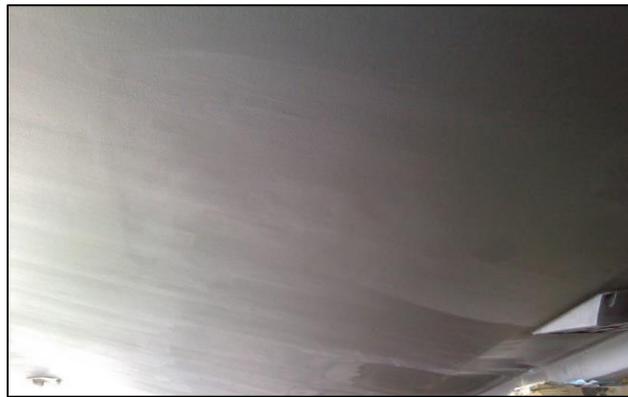
Looking Forward

**Infrared Test Results:** The following four, grey scale thermal images were taken of a recent repair to the hull of an 80' Viking Sport Fisherman. These images will demonstrate the different quality of images obtained by using a higher hertz and resolution imager in comparison to an imager with lower hertz and resolution.

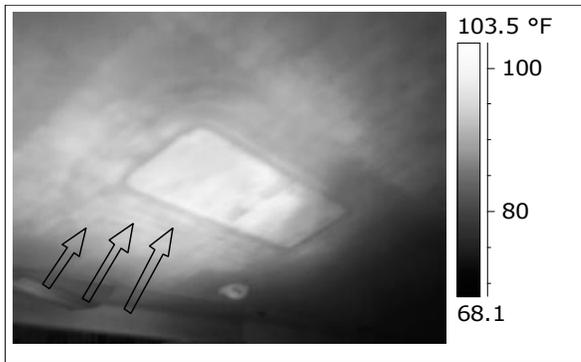
FLIR T440BX

As you can see, the above images show that the T440BX gives you the definition and delineated edges needed for proper inspection. The T440BX actually shows the layers of tabbing for the fiberglass insert, indicated by the black arrows in the images above.

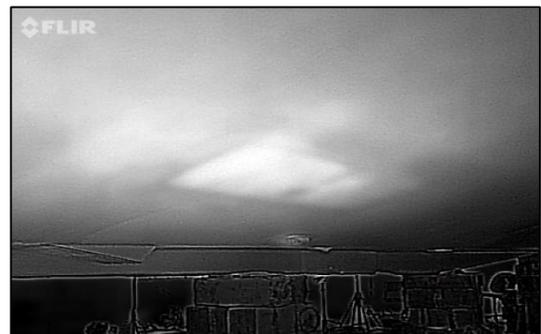
FLIR One using MSX®

The C2 and FLIR One are too distorted and do not show enough detail and information to do a proper laminate inspection. The FLIR One image could not be thermally tuned using the recommended software in a computer but could be tuned using aftermarket software and the iOS 9.2.1 application. Having an image with specific detail is important for a contractor or boat owner. It documents that repairs are correct and precise.

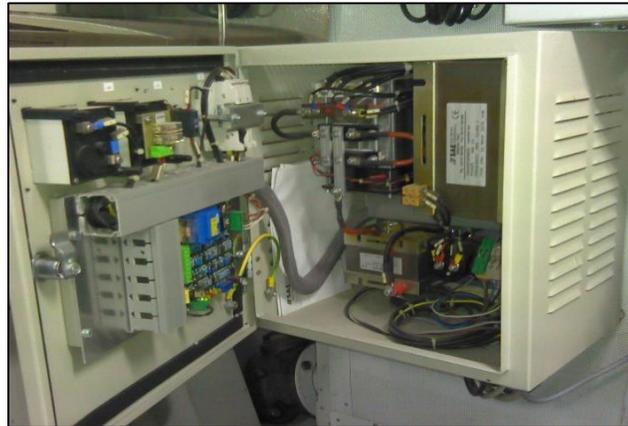
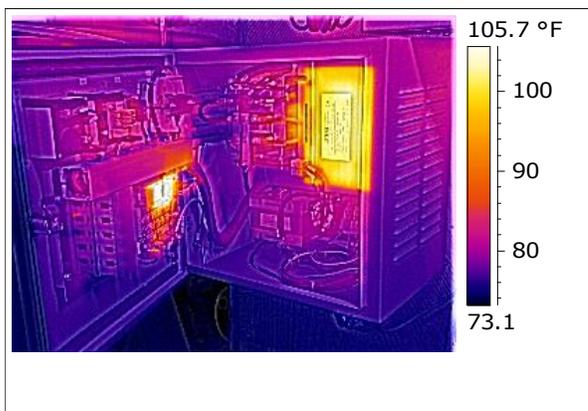
FLIR T440BX

The following two, iron scale thermal images taken of a normal operating battery charger imaged with Multi Spectral Dynamic Imaging or MSX<sup>®</sup>. MSX<sup>®</sup> adds key details from the visible light camera to the entire thermal infrared image<sup>v</sup>. This shows which imager gives enough visual information to do a proper inspection. MSX<sup>®</sup> does require that you have good visible light for the imager unless you can thermally tune the image using the proper computer software.

As you can see in these images, the T440BX gives you definition and delineated edges for the electrical inspection. The FLIR One image was slightly distorted. A clearer image is necessary when using MSX<sup>®</sup> so the inspector can identify the problem area with enough detail to provide useful advice and/or information.

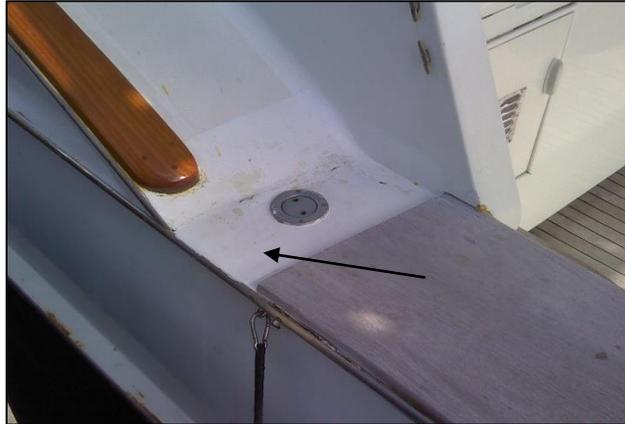
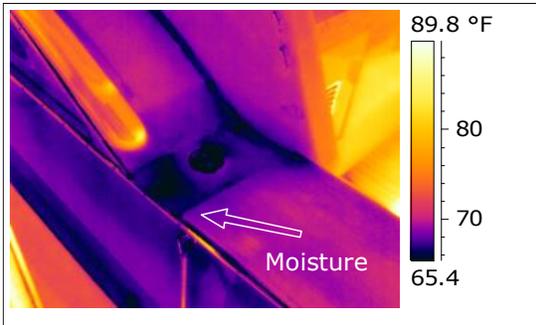
FLIR T440BX

The following eight, iron scale thermal images taken of the port side deck fuel fill and cockpit bulwarks of a 72' Blackwell Boatworks Sport Fisherman will outline and demonstrate which imager is best for moisture ingress and/or water intrusion in fiberglass laminates.

As you can see, the T440BX give you the definition and delineated edges for the inspection. With the Spot1 (Sp1) and Sp2 temperature readings, the T440BX and E6 show close to a ten degree Fahrenheit temperature difference, while the C2 showed just under a six degree temperature difference. The E6 is slightly distorted while the C2 and FLIR One are quite distorted and do not show what you need to do a proper inspection by defining the actual area of concern as indicated by the black and white arrows. An actual Delta T could not be determined in the FLIR One image.

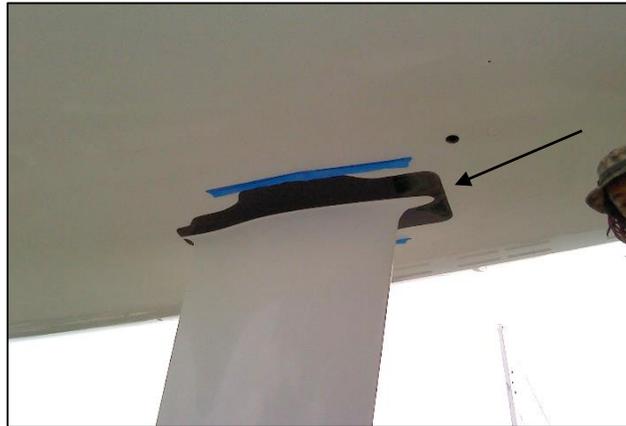
FLIR T440BX

The following two, grey scale thermal images taken of the carbon fibre keel flange of a 52' Transpac TP52 Sailboat will outline and demonstrate which imager is best for vessels constructed of carbon fibre.

The above images show that the T440BX gives you the definition and delineated edges for good inspection. The C2 is distorted and does not show what you need to do a proper inspection.
